Tikrit Journal of Engineering Sciences

Abdulrahman MB, Rashid HM. Repairing of reactive powder concrete T-beams containing web opening by CFRP Strips. *Tikrit Journal of Engineering Sciences* 2019; 26(1): 9-19.

Repairing of Reactive Powder Concrete T-Beams Containing Web Opening by CFRP Strips

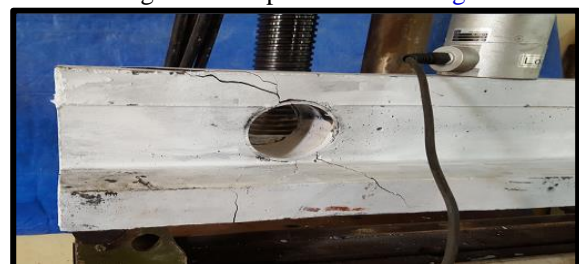
(a) Before repaired.

Fig. 3. The beam testing.

Repair process of the beams is shown in Fig.3, including steps which are: cleaning the beams, injecting and filling the cracks using epoxy and finally application of CFRP strips. Seven beams were wrapped on the area of failure using CFRP strips as shown in Fig. 3.

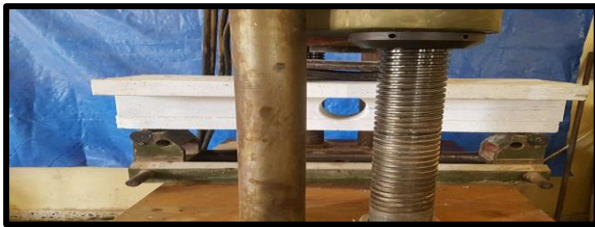
Fig. 4. Beams under testing.

All beams were cured for 28 days period, and then coated with white color so that cracks can be easily detected. All beams were tested using a universal testing machine of 2500kN capacity under static loads until failure. A dial gauge of 0.002 mm accuracy was attached securely to the bottom of the tension face of mid-span to measured deflection in beams. The tested beams were simply supported over an effective span of (900mm) and loaded at two-point, load Fig. 4.

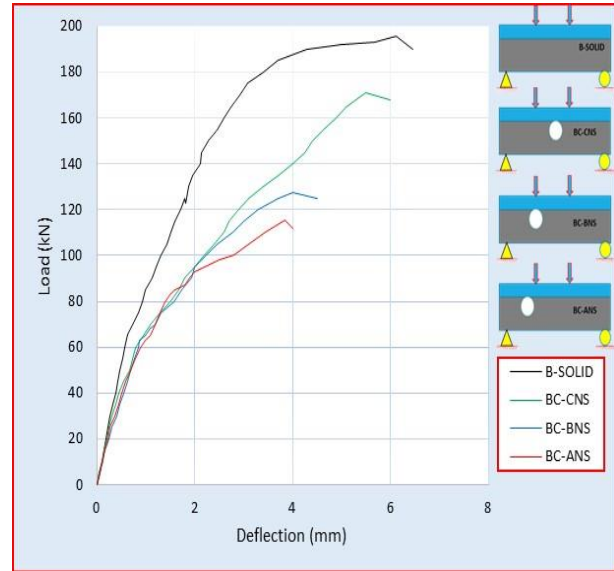
Fig. 6. Load - deflection curve for beams with circular opening at different locations.

To study the effect of the opening location, a three different locations were investigated ($L_c/2$, $L_c/3$, and $L_c/4$) measured from the support to opening center. The test results showed that providing an opening at $L_c/4$ caused the sharp reduction in beam strength by (48%) while providing an opening at $L_c/3$ caused the reduction in beam strength about (38%) whereas providing an opening at $L_c/2$ caused reduction in the ultimate load about (11%). as shown in Figs. 6 and 7.

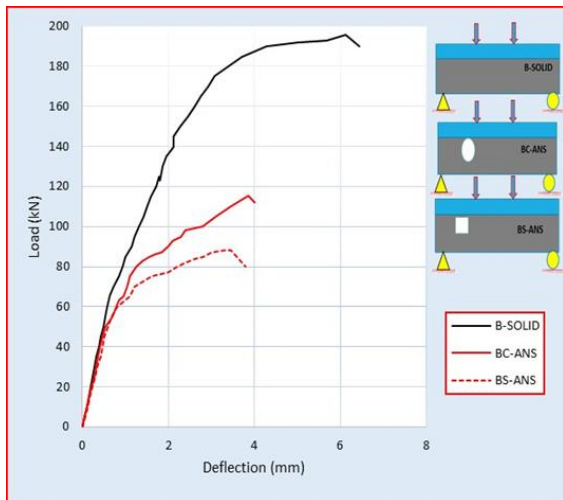
Fig. 10. Load-deflection curve for beams with circular and square opening at $L_c/4$.

The reason behind that reduction for the square opening is that the existing orthogonal corners caused more stress concentration at these corners. The sudden change in the dimension of the cross-section of the led to the high-stress concentration at the corners of square opening that may lead to undesirable cracks as shown in Figs. 8-10.

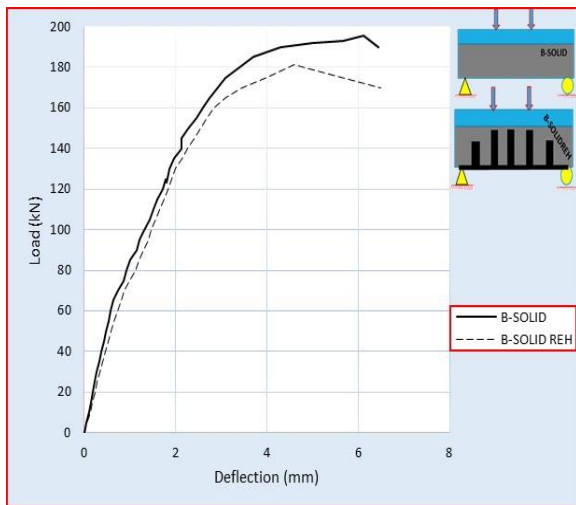
Fig. 13. Load-deflection of control repaired beam.

General test results show that the repaired beams with CFRP laminates gain high efficiency in ultimate strength. The ultimate load of the reference beam after repairing is less than the ultimate load of the reference beam before repairing, as well as the deformation of reference repaired beam was greater. As for the beams that containing the openings, it was observed that the ultimate load of the repaired beams is more than the ultimate load the same beams before repair and this indicates the efficiency of carbon fiber in the repairing of beams. The ultimate load is recovered for the repaired solid beams was about 92%. While the ultimate load for the beams with openings were from about 98% to 115% compared with the same beams before the repaired as shown in Figs. 12-18.

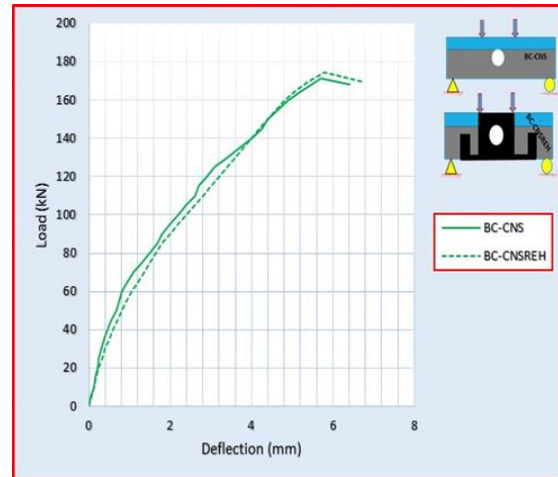
Fig. 14. Load-deflection of circular opening in mid span repaired beam.

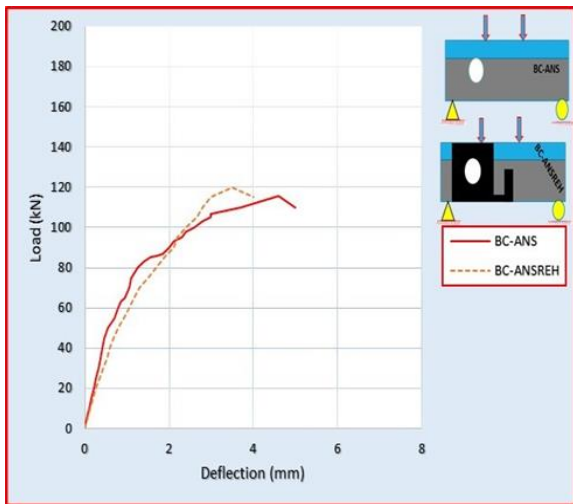
Fig. 16. Load-deflection of circular opening at Lc/4 repaired beam.

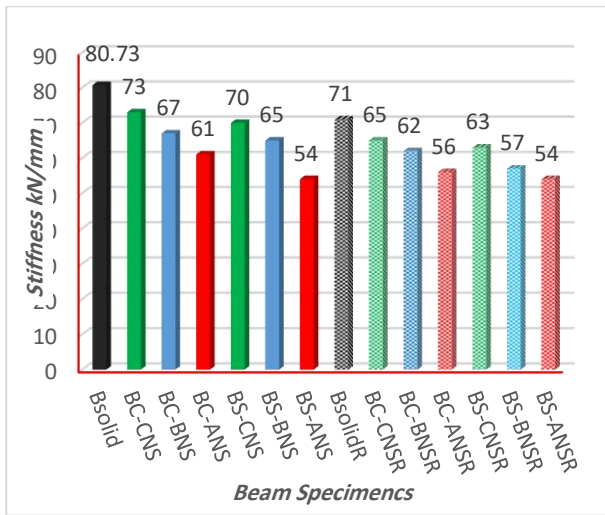
Fig. 21. Stiffness in beams.

From the (load-deflection) curves it was found that the presence of an opening in beams decreased the stiffness of RPC beams (the stiffness is the ratio between the 45% from ultimate load to deflection at the 45% from ultimate load). For the control beam, the stiffness is equal to 80.73. For group one, for a circular opening, the stiffness for the tested specimens BC-CNS, BC-BNS and BC-ANS were equal to 73.37, 66.67 and 61.14 respectively. In the other side, for group two, with square opening the stiffness for the tested specimens BS-CNS, BS-BNS and BS-ANS were equal to 68.98, 64.68 and 54.30, respectively.

The reason behind this decrease is the moment of inertia due to opening. Also, through (load- deflection) curves of the repairing beams, it is noted that these beams are less stiffness than the undamaged beams. The reason behind this decrease due to the presence of cracks in the rehabilitated beams before test and decreasing the moment of inertia due to opening as shown in Fig. 21.

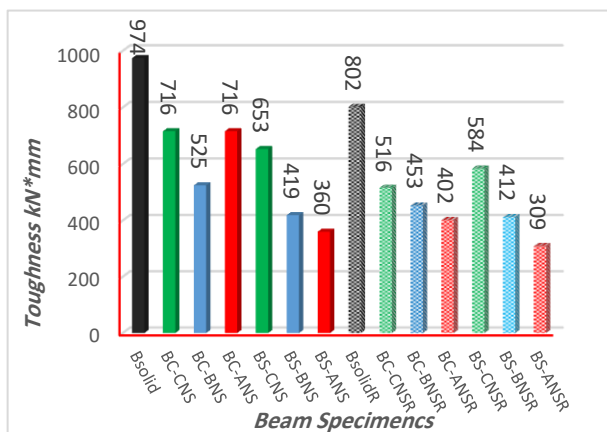
Fig. 22. Toughness in beams.

From the (load-deflection) curves it was found that the presence of an opening in beams decrease the toughness of RPC beams (the toughness is the area under the curve). For the control beam, the toughness is equal to 974.11kN.mm. For group one, for a circular opening, the stiffness for tested specimens BC-CNS, BC-BNS and BC-ANS were equal to (716.019, 525.549 and 420.506) kN.mm, respectively. In the other side, for group two, with square opening the stiffness for the tested specimens BS-CNS, BS-BNS and BS-ANS were equal to (653.80, 419.46 and 360.52) kN.mm, respectively. Also, through curved (load- deflection) of the rehabilitated beams, it is noted that these beams are less toughness than the undamaged beams. The reason behind this decrease due to the presence of the openings which reduce the resistance of the first crack and also lead to the extended cracks and make it wider and thus reduce the amount of energy absorbed and, in this case, reduces the toughness as shown in Fig. 22.
